DESCRIPTION OF THE LAND

DESCRIPTION OF THE IMPROVEMENTS

Existing Improvements

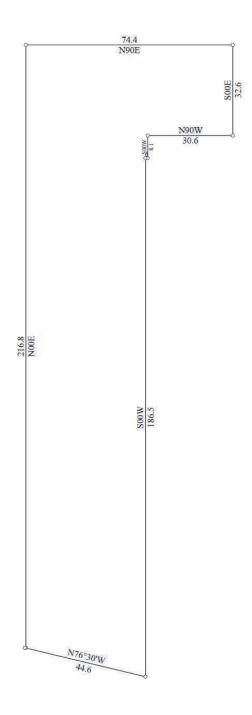
DEED PLOTTER PRINTOUT SHOWING THE SUBJECT PROPERTY

The subject site contains a total of approximately 10,600 square feet (0.24 acres). A survey of the subject site is not available; thus, we have utilized the Deed Plotter+ for Windows, Version 4.14 (published by Greenbrier Graphics, Inc.) in order to estimate the land area. The metes and bounds from the legal description have been entered into this program; the direction along Howard Avenue is given in the legal description only as "northwest", so we have manually forced the sketch to close. The resulting land area has been rounded by the appraisers to 10,600 square feet.

The site is somewhat irregular in shape but fully usable, with generally level topography. The short extension in the northeastern corner of the subject site encompasses part of a small parking lot (only 2 to 3 parking spaces); otherwise, the site is mostly covered by the building. The subject site has 44.6 feet of frontage on the northwest side of Howard Avenue (Vieux Marché Mall) and 216.8 feet of frontage on the east side of Croesus Street. The right-of-way of Croesus Street has evidently been vacated. At this time, exposed-aggregate pavement is in place along this former street, with lawn and landscaping along either side; although the pavement is probably drivable, it is apparently intended to be a pedestrian walkway only. The eastern boundary line runs mostly though not entirely through a party wall with the adjoining building; party walls like this are commonplace in downtown Biloxi.

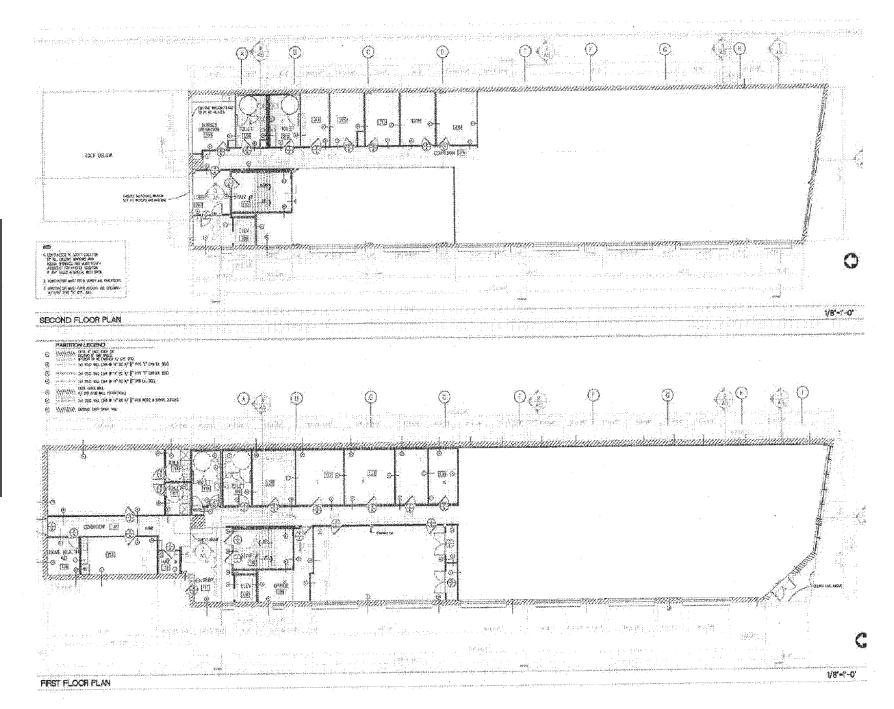
Provided into Deemed Accurate But Not Warranted

The subject property is improved with an historic building that is under renovation for use as a nightclub that will contain 25,119 square feet. Most recently, the subject property was occupied as medical offices by Saad's Medical Management, Inc. apparently as shown on the following floor plan.

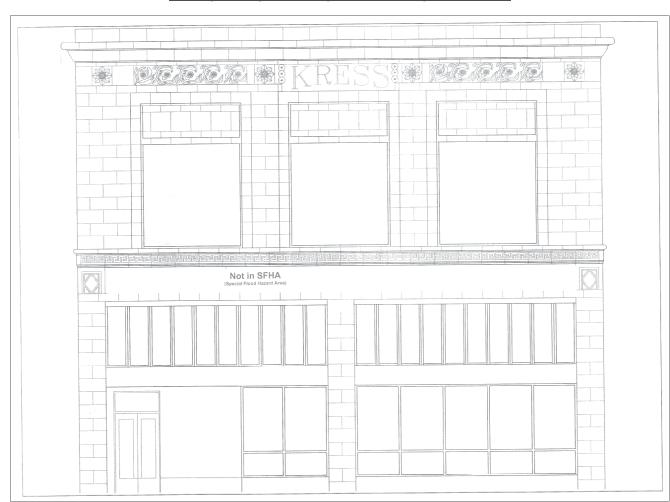
Drawing Showing the Building Façade Following the Renovation

The structure is known as the Kress Building and was built in 1948 according to Harrison County Tax Assessor's Office records. The one-story rear wing of the building might have been added at a later date, although this is uncertain. The building was formerly occupied by a "five and dime store" chain operated by S. H. Kress & Company. The Kress buildings are known for their attractive art-deco façades, and many of these buildings have been renovated for other uses throughout the nation. The subject building is evidently typical of these structures, and the name "Kress" is imprinted on the façade near the roof line. A drawing that shows the façade as it will appear following the renovation is given on the preceding page.

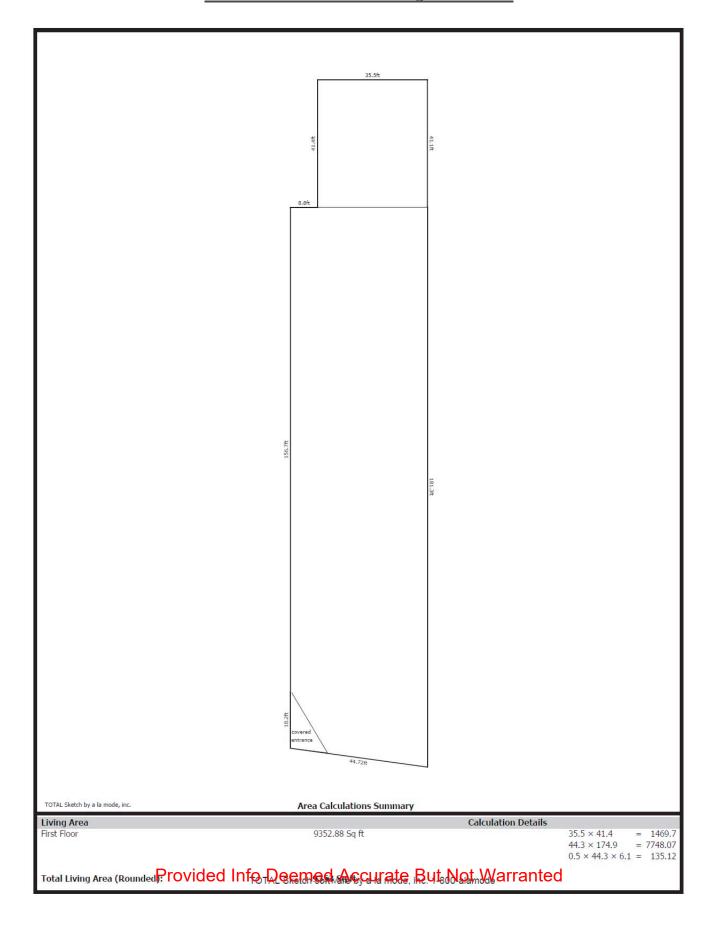
Exterior Outline of the Building – First Floor

Floor plans that are based upon measurements that were made by the appraiser in the field are given on the following pages. Some distances are given on the renovation plans, including the distance along the party wall, though most are not shown. The owners have been approved for historic tax credits on the renovation of the space; upon investigation, the recessed entrance on the first floor was evidently not original to the building. During the renovation, this corner will be squared off; this is reflected in the gross building areas shown, though the covered entrance is also indicated, since it is shown on the basement floor plan on the renovation plans. However, the basement area is not included in the gross building area.
